Manhole Inspection Summary

Manhole # S25G__034MH

Insp Date: **4/15/08 4:32 AM**

Location Address: **1126 BALTIMORE ST**

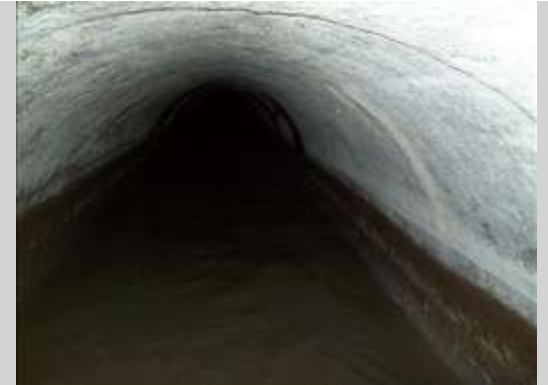
12 O'Clock Outflow

54 in. Circular Gravity Sewer
Pipe Out @ 12 O'Clock

Pipe Height: **61.2** (in.) Direct (Angled)
Pipe Material: **Concrete** ☐ Pipe Lined
Invert Depth: **24.77** (ft.) Flow Characteristics: **Slow**
Deposits: ☒ None ☐ Mud ☐ Sludge ☐ Debris ☐ Grease
Silt Depth: (in.) Deposits Extent:
Infiltration: **None** Pipe Seal Cond: **Sound**

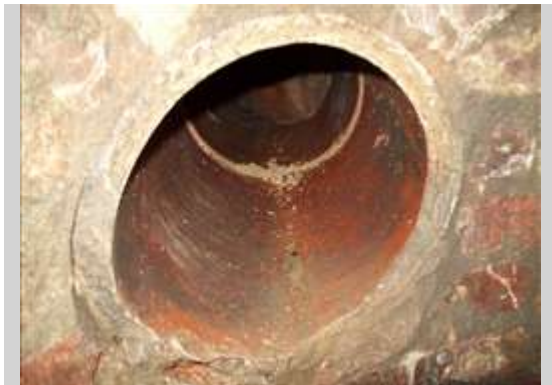
3 O'Clock Inflow

8 in. Circular Gravity Sewer
Pipe In @ 3 O'Clock

Pipe Height: **8.4** (in.) Direct (Angled)
Pipe Material: **Clay** ☐ Pipe Lined
Invert Depth: **11.14** (ft.) Flow Characteristics: **Slow**
Deposits: ☒ None ☐ Mud ☐ Sludge ☐ Debris ☐ Grease
Silt Depth: (in.) Deposits Extent:
Infiltration: **None** Pipe Seal Cond: **Sound**

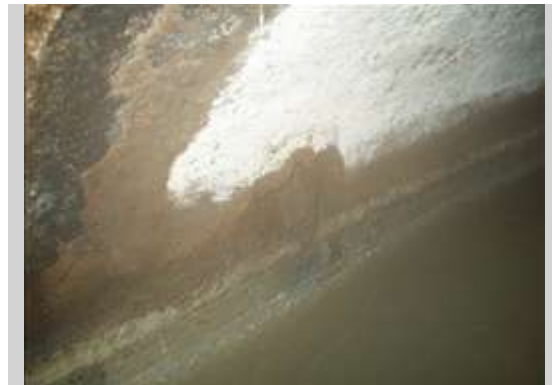
Drop In @ 3 O'Clock

Drop: **Outside Direct**
Angled: **Yes** Reading: **19.75** (ft.)
Inv Depth: **21.47** (ft.)
Drop Condition: **Open**

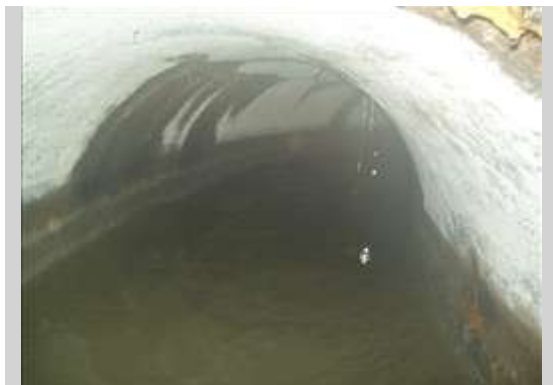
6 O'Clock Inflow

54 in. Circular Gravity Sewer

Pipe In @ 6 O'Clock

Pipe Height: **60** (in.) Direct (Angled)

Infiltration: **None** Pipe Seal Cond: **Sound**
